Manhole Inspection Summary

Manhole # **S31A__028MH**

Insp Date: **10/16/07 1:20 PM**

Location Address: **512 JASPER ST**

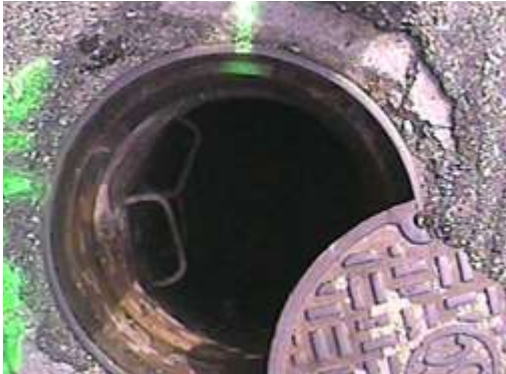
Defect 2

Condition: ☐ Sound ☐ Cracked ☐ Root Intrusion ☐ Loose Brick ☒ **Deteriorated**

deteriorated corbel

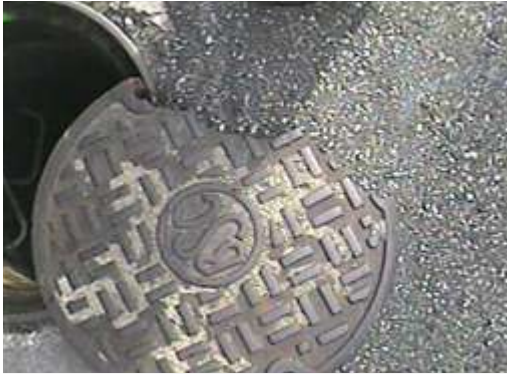
Defect 1

Condition: **Broken**

BROKEN LID

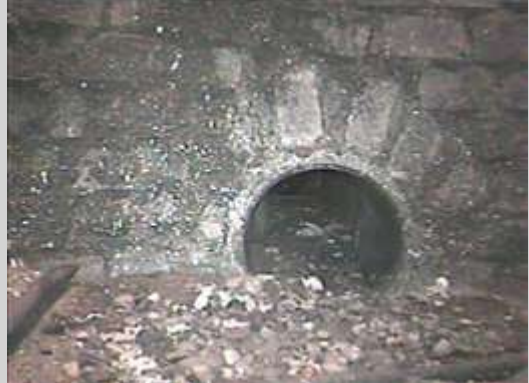
12 O'Clock Outflow

10 in. Circular Gravity Sewer
Pipe Out @ 12 O'Clock

Deposits: ☐ None ☐ Mud ☐ Sludge ☒ **Debris** ☐ Grease

Silt Depth: **1.5** (in.) Deposits Extent: **Light**
